BELZONA REPAIRS AND PROTECTS A SAND FILTER AT A NUCLEAR POWER PLANT

Sand filter in a Nuclear power plant

Internal corrosion

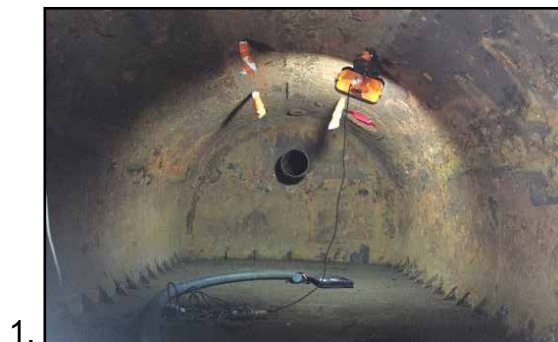
1. Before application
2. Surface aspect before surface preparation
3. After surface preparation
4. After application

The application was carried out in accordance with Belzona Know-How System Leaflet TCC-5. After grit blasting the substrate, it was degreased and the pitting was repaired with Belzona 1111. The surface was then protected with Belzona 1321 to prevent any future corrosion.
