## BELZONA CREATES POSITIVE GRIP ON RUBBER CLAD CONVEYOR DRIVE ROLL

Anti-slip chevron strips were applied directly onto an existing worn rubber lining of a conveyor drive roller. This was done without removing the lining and without dismantling the roller.

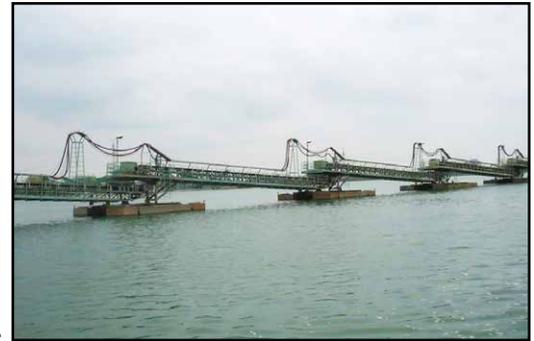
1. Floating conveyor systems used for transporting gravel
2. Worn out rubber cladding
3. Preparing for the installation of Belzona 2111
4. Fully applied system

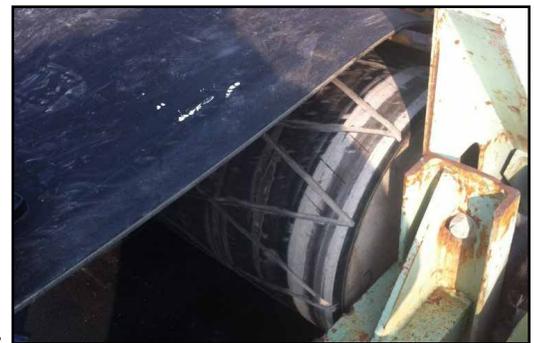
2.

Worn rubber cladding was allowing belt slippage on a floating conveyor system used for transporting gravel. Whenever it happened on one of the rollers, the whole system would stop and it takes 30 minutes to restart it back to operating at full service. In rainy periods of the year this happens often and it is a significant loss of production time.
