## INTERNAL REFECTION OF A CENTRIFUGAL PUMP USING BELZONA

Inside of a centrifugal pump

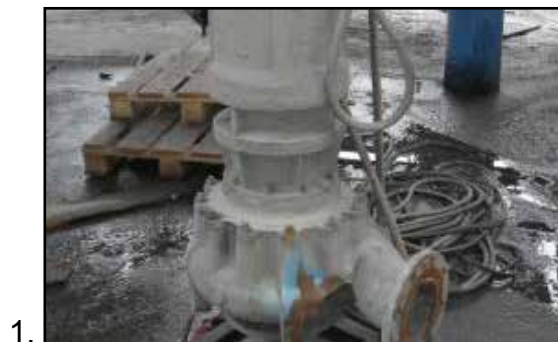
The inside of this pump was badly damaged by entrained solids as it pumps river water. The high speed of the fluid also accelerated the deterioration.

1. Overview of the equipment
2. Zoom on the main defect on the discharge outlet
3. Reinforcement with the metallic net
4. Final application
