BELZONA APPLIES ANTI-SLIP SYSTEM TO WOODEN MEZZANINE FLOOR

Distribution Center, Worksop, UK

2019

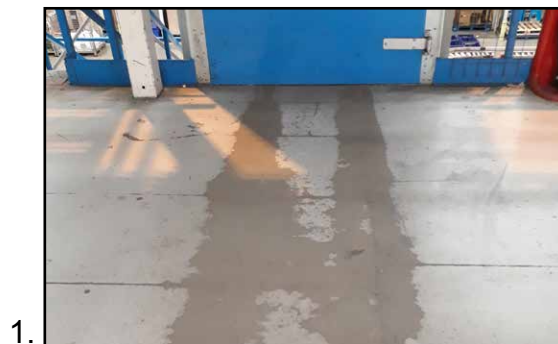
1. Small trial area
2. Dolly pull-offs in place
3. Applying 2nd Coat
4. Trial completed

5231 was applied to a small patch, along with pull-off dollies as a small trial area. These showed adhesion approaching 850 psi. From this result, a larger trial was organised. Preparation was completed using large floor sanders and vacuums, followed by the application of the Belzona 5231 in accordance with Belzona system leaflet FPA-8.
