## BELZONA REPAIRS THE SUCTION PART OF A HYDRO TURBINE

Suction part of a hydro turbine from a hydroelectric plant

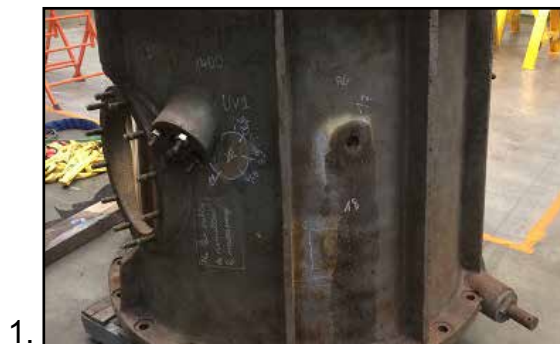
The internal surface of this hydro turbine presented an important loss of metal which ultimately led to a hole.

1. Before application
2. After grit blasting
3. Application of Belzona 1311
4. Completed application
