BELZONA ELASTOMER SOLUTION FILTERS OUT THE COMPETITION

15-year-old limestone filter at a power plant.

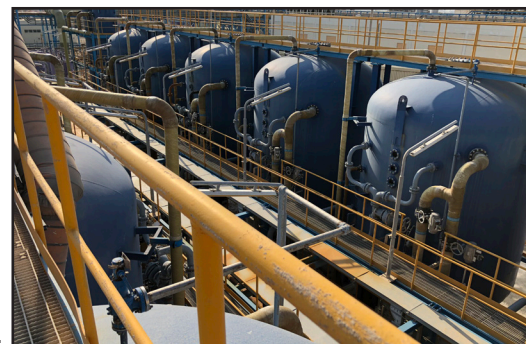
1. Limestone filters at the power plant.
2. Alternative rubber lining disbonded during a trial phase
3. Alternative protective coating blistered during a trial phase
4. Belzona 1331 - No traces of failure after 8-month trial period.
