## SEVERE CORROSION STOPPED WITH BELZONA 3111 (FLEXIBLE MEMBRANE)

Municipal power authority, Texas USA

Lime slurry reclaim tank. Client needed a long-term repair to an unusual corrosion problem.

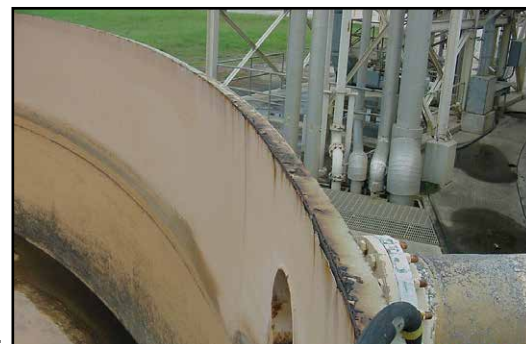
Severe corrosion caused paint delamination on top of exposed reclaim tank walls.

1. The corroded reclaim tank wall
2. Surface prepared and conditioned with Belzona 3921
3. First coat of Belzona 3111
4. Top coat of Belzona 3111 applied
