RUBBER LINED CONDENSER WATER BOX REPAIR REQUIRES BELZONA

Power Plant, Western Region of Saudi Arabia

Condenser Water Box

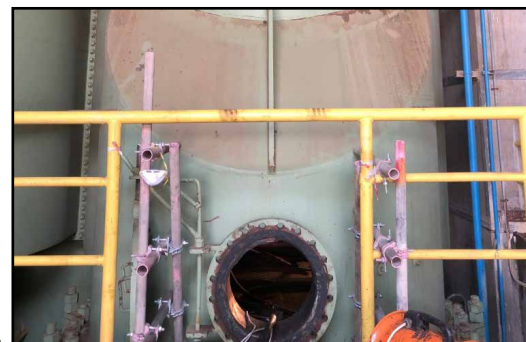
1. Application overview
2. Close up of damage showing erosion and cavitation damage
3. The water box repaired with Belzona 1311

The repair was completed in accordance with Belzona Know-How System Leaflet WPA-1. The rubber was undercut and all loose surface contamination was removed. After achieving correct surface preparation, Belzona 1311 was applied and contoured to the required profile.

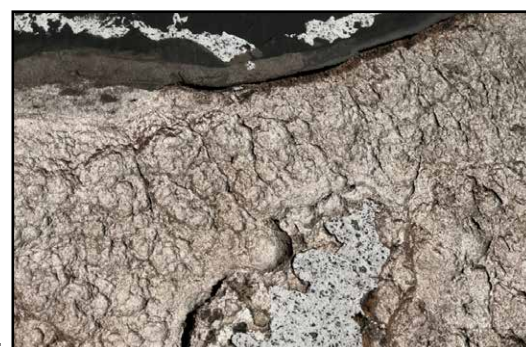
Inspection during the Power Plant shutdown showed severe erosion on the rubber-lined condenser water box, with thickness loss of around 5-6 millimeters in localised areas.

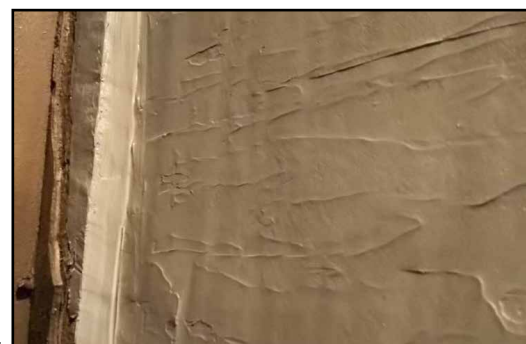
One year later, the application is performing very well and working without any problems.
