BELZONA FORMS THE FACES OF 132 SEA WATER FLANGES

Petrochemical Plant, Saudi Arabia

132 Class 150 - 14", 24", 26", 30", 40" & 48" pipe line flanges operating at 7 to 8 bar

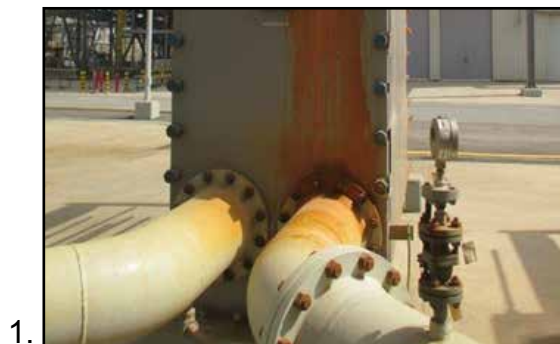
A new utility sea water cooling facility was commissioned 1 year ago for this plant. Already, the effects of sea water were leading to crevice corrosion on many diameters of pipe line flanges. This was leading to worn out serrations and severe damages on the seating faces. Existing fusion bonded epoxy coating failure inside the spools was due to sea water penetration and pitting corrosion on the edges of spool. Leakages observed through various flange faces and weld seams were leading to intermittent shutdowns.

1. Sea water leaking through the flanges
2. Flange damage on the edges
3. Application of Belzona 1111 on the flange to form peaks
4. Completed application of a 48" flange
