BELZONA REPAIRS A CHASSIS ON AN AIR-COOLING SYSTEM

Chassis of a gear reducer on an air-cooling system in a nuclear power plant.

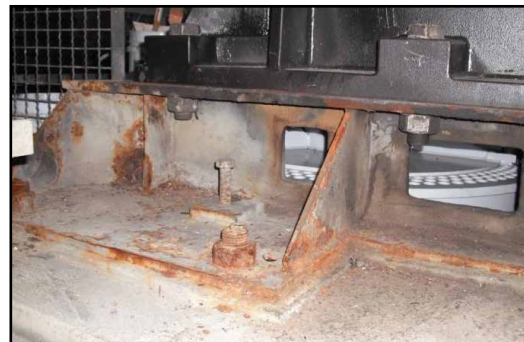
The water circulating in this equipment was treated with CO₂ and other additives against legionella causing an important problem of corrosion.

1. Before surface preparation
2. After surface preparation
3. Overview of the air-cooling equipment
4. Final application

Application was carried out in accordance with a modified version of Belzona Know-How System Leaflet FBC-2. The substrate was first prepared with a needle gun and grit blasted. Then, one coat of Belzona 5831 was applied at 600 microns.
