## BELZONA REPAIRS AND PROTECTS AN SEC PUMP

Cutwater of a SEC pump

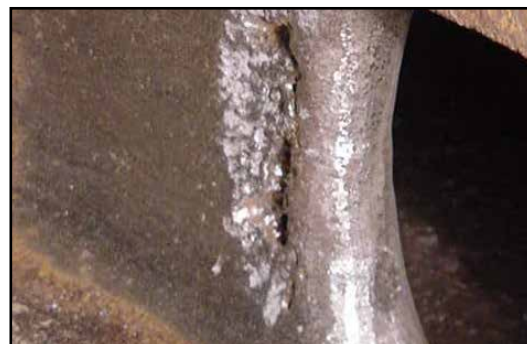
1. Before application
2. Final application

The cut-water of this pump was damaged by erosion/cavitation and needed to be rebuilt and protected.

The rebuilding step was done with Belzona 1311 in accordance to Belzona System Leaflet CEP-1. The area was then protected by overcoating with Belzona 1341.
