BELZONA PROTECTS AN SEC FILTER IN A NUCLEAR POWER PLANT

The volute of an SEC filter

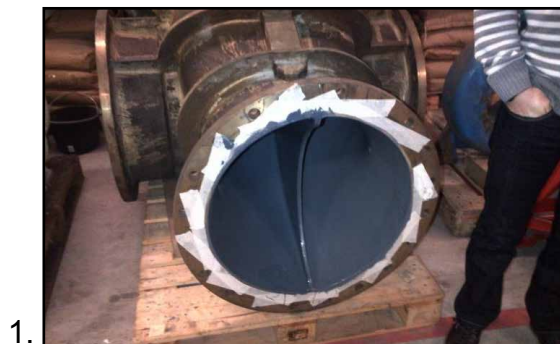
1. Finished application
2. Overview of the equipment

Application was carried out in accordance with Belzona Know-How System Leaflet CEP-5. After preparing the surface, 2 coats of Belzona 1321 were applied inside the filter (800 microns in total).

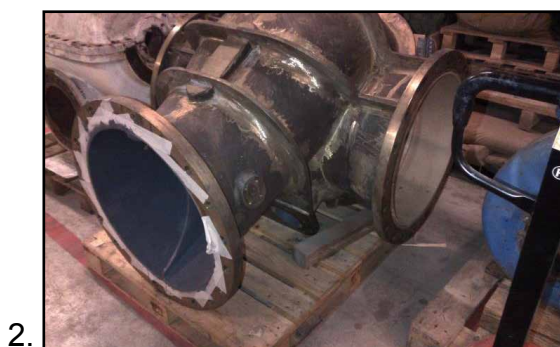
The volute of this SEC filter was damaged by erosion. The micro-porosity generated by the erosion resulted in the oxidation of the copper visible from the outside.
