## BELZONA REPAIRS 42 BAR ACTIVE GAS LEAK

### CUSTOMER

Egypt

Fertilizer plant gas leak was causing health and safety problems.

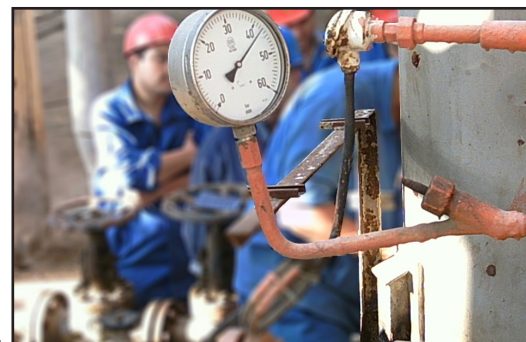
1. Pressure gauge on pipe showing 42 bar.
2. Belzona 9611 clamped down on the repair.
3. The application of Belzona 1111 underway
4. Application complete.
