## BELZONA RECONSTRUCTS THE COVER AND FLANGE OF A HEAT EXCHANGER

Petrochemical Plant, Gabon

Cover and flange of a heat exchanger

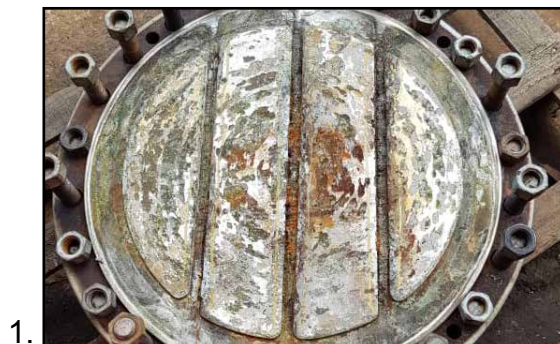
The flange and the cover of this exchanger were badly damaged by corrosion and needed to be rebuilt.

1. Cover before application
2. Flange before application
3. Flange after application
4. Cover after application

The substrate was first grit blasted to ensure a good mechanical bond with the product. Belzona 1111 was then used to rebuild the cover and the flange according to a modified version of Belzona Know-How System Leaflet HEX-02. Finally, the 2 parts of this equipment were machined back to the correct dimensions.
