BELZONA REFURBISHES SCHOOL ROOF

Hall/Classroom roof at a School

Due to age and cracks in both the parapet walls and in the ashfelt the roof was leaking into the classrooms below.

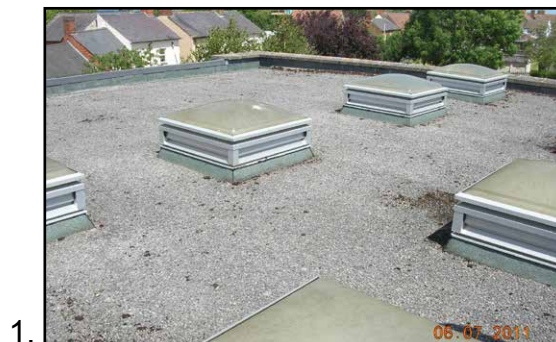
1. Before repair
2. Before application
3. Completed application
4. Completed application
