## BELZONA REPAIRS SCREW FEED TROUGH

Restoration of a screw feed trough used for waste management.

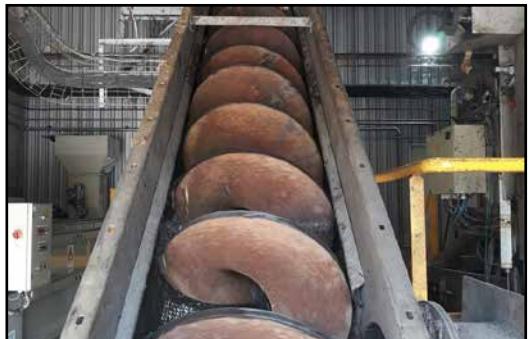
This screw conveyor was used for the movement and separation of media such as glass, plastics and general waste for a landfill site. The harsh media going through the screw conveyor was causing severe abrasion on the screw feed trough leading to regular cracks and repairs through welding, this meant massive regular downtime for the client and they wanted to find a long term solution.

1. Before application - Previous 1.5m trial section can be seen at the bottom of the feed
2. Close up of the 1.5m trial patch after 6 months in service
3. Start of preparation and application of the Belzona 1814 section
4. Final application

This application was carried out in accordance with a modified version of system leaflet SMH-07. The surface of the screw feed trough was prepared and cleaned before the top section of the trough was applied with Belzona 1814, the majority of the trough was then applied with Belzona 1811. The Belzona 9811 alumina tiles were also incorporated with the Belzona 1811 and Belzona 1814 to create a high abrasion resistant system.

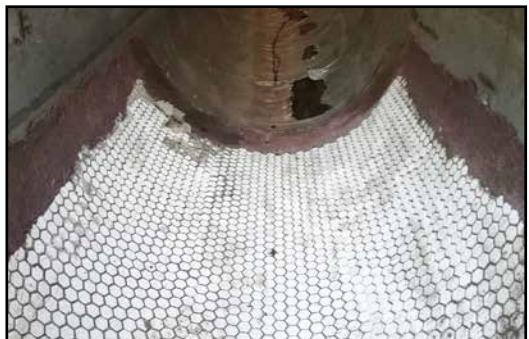
2.

It was agreed a 1.5m trial application would be carried out before the whole screw conveyor was to be repaired as this was the clients first time using Belzona. 6 months after the original trial the results showed the Belzona system to still be in excellent service condition. The client was extremely happy with the results and agreed to proceed with the whole screw conveyor. To follow the strict time scale the whole application was carried out in 2 days and a total of 180Kg of Belzona 1811 and 1814 was used.
