BELZONA REPAIRS TO PROTECT TANK SUPPORTS

Steel Production Site, Lincolnshire, UK

Diesel storage tank showing signs of corrosion.

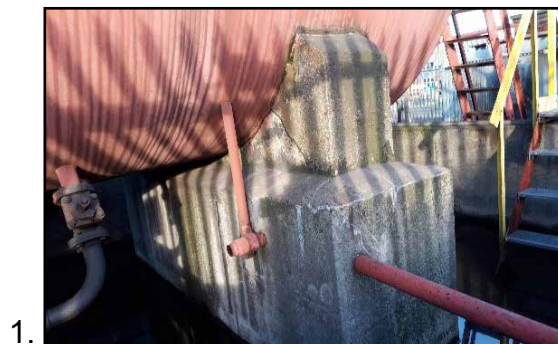
The tank and concrete saddles were showing some minor signs of corrosion at the joints. This was caused by standing water in these areas. The damage to the tank coating and concrete were only minimal, however if they were not repaired, the damage would have continued to deteriorate causing potential failure of the tank or the supports in the future.

1. Area of concern
2. Belzona concrete rebuild completed
3. Conditioner applied
4. Completed repair to tank supports
