## BELZONA REPAIRS SWIMMING POOL

Kwidzyn (Poland)

May 2011

Concrete crack on the bottom of the swimming pool .

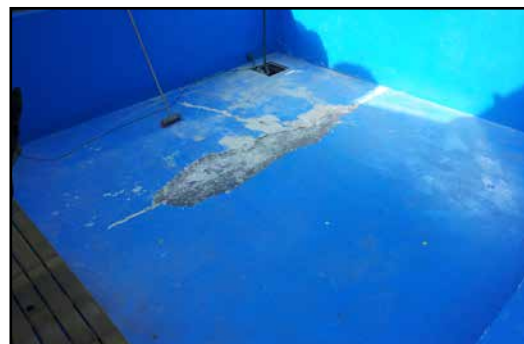
A significant water leak from the pool due to the crack of the concrete.

1. General view of the damaged bases
2. The bottom of the pool after the application of Belzona 4151
3. Supplementing concrete damage - Belzona 4111.
4. General view of the swimming pool.

Previous repairs to other materials did not cause inhibition of the leak. Removed loose and wet concrete parts. The entire exposed concrete was painted Belzona4151. At the end of applied Belzona 4111.
