## BELZONA SAVES A CORRODED AIRTIGHT COMPARTMENT

Airtight compartment on a shipyard

This compartment filled with air and used for underwater works was badly corroded and needed to be repaired and protected.

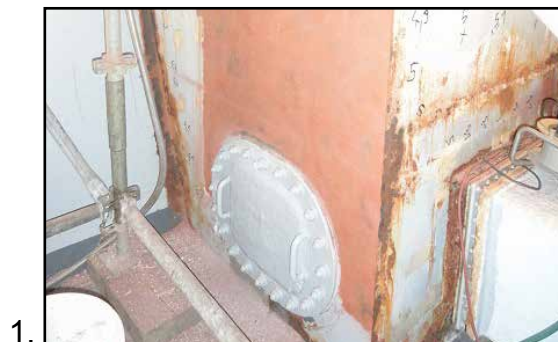
1. Before application
2. After surface preparation
3. Installation for the application
4. Final result
