## BELZONA PROTECTS SCREW CONVEYOR AGAINST ABRASIVE ATTACK

Biomass Plant, Glasgow, UK

Screw conveyor used to skim sludge from the base of a silo at a biomass plant.

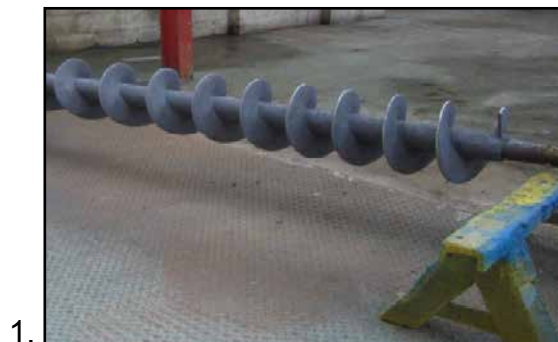
1. Close up of the material
2. Belzona 1814 applied
3. Unprotected screw conveyor

The application was completed in accordance with system leaflet SHM-14. The screw conveyor was grit blasted to SA2 1/2 with a minimum surface profile of 3 mil (75 microns). The area to be coated was then cleaned and degreased using Belzona 9111. Belzona 1814 was applied by brush to the entire area of the conveyor to provide long-term protection against heavy abrasion.

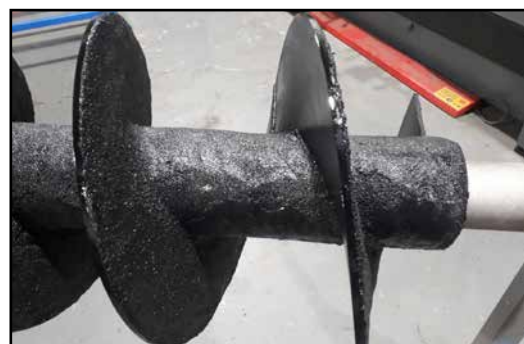
3.

High abrasion was leading to unprotected screws only lasting 3-4 months in service. Previous Belzona applications on this type of screw was completed with Belzona 1812, which extended their life to over 2 years.
