## BELZONA SOLUTIONS FOR HEAT EXCHANGERS

Burbank, CA

December 2020

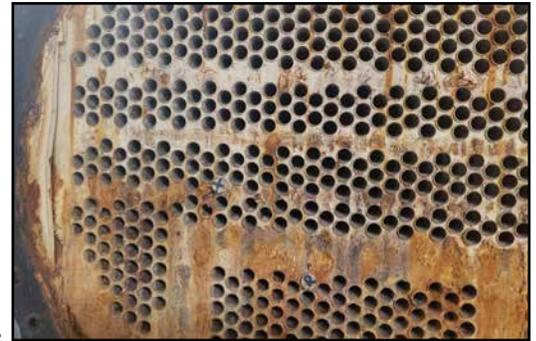
Shell and tube heat exchangers are a vital part of any heating or air conditioning system. Failure to quickly protect these units allows galvanic corrosion to take place, resulting in wastage and metal loss on the tube sheet around the coolant tubes. Left untreated, the loss of metal can cause leakage of the coolant and contamination of the chilled water. Corrosion is not restricted to the tube sheet, the water box and end covers can also be affected. Corrosion in division bars and seal faces can lead to leakage and loss of efficiency, as well as the inability to maintain the desired working environment in buildings.

If the corrosion allowance is exceeded and gaps appear, recirculation can occur, leading to efficiency loss. In addition, the processed fluid can erode the metal further, accelerating degradation if corrosion is already present.

1. Corroded tube Sheet
2. Blasted Tube Sheet
3. Repaired and Coated
4. Final Results of Repair

The affected section was rebuilt using Belzona 1311 to its original tolerances and Belzona 1321 was applied to provide a layer of durable protection. This cold-applied repair process bypasses the need of hot work that would leave the substrate susceptible to further damage. Belzona polymeric technology isolates the dissimilar metals, preventing further galvanic corrosion. The tough repair and coating system also protects the chiller against the effects of erosion and, as a result, increases asset life and efficiency while avoiding replacement.

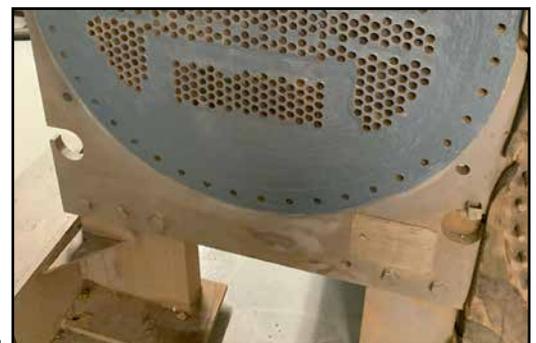
4.

The Belzona solution not only restores the original tube sheet profile, but also creates a smooth tube sheet face flush with the tube ends, leading to reduced turbulence and greater efficiency. Water boxes and end covers can also be repaired and protected.
