## BELZONA LINES HIGH TEMPERATURE ETHANOL VESSEL

Refinery, Scotland

November 2020

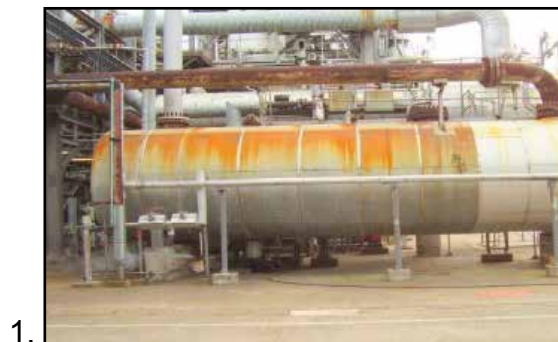
1. Vessel external
2. Belzona 1511 applied to areas of weld overlay
3. Belzona 1593 first coat
4. Belzona 1593 second coat
