## BELZONA PROVIDES COLD BONDING SOLUTION TO STORAGE TANK

Glass fused steel storage tank suffering from internal corrosion

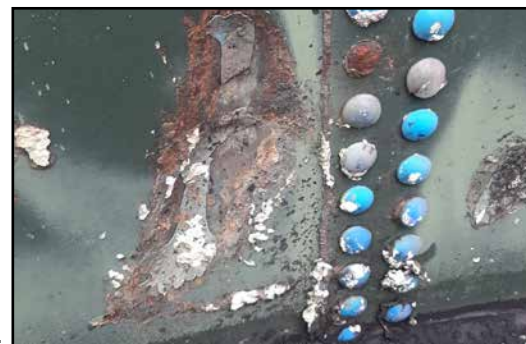
A crisp factory located in Dublin, Ireland, had suffered from corrosion within a storage tank containing process wastewater. Over time, the glass fused steel resulted in multiple through-wall defect areas on the substrate surface, which if left untreated, could have produced a serious problem with environmental and economic impacts. The Customer was in need of a quick, yet simple solution that ultimately ruled out the need for replacement and one that would have minimal impact on production.

1. Damage to the surface
2. Surface preparation and plate bond using Belzona 1111
3. First coat of Belzona 5811
4. Second coat of Belzona 5811
