PUMP REPAIR WITH BELZONA

Cellulose production plant, Slovakia

2010

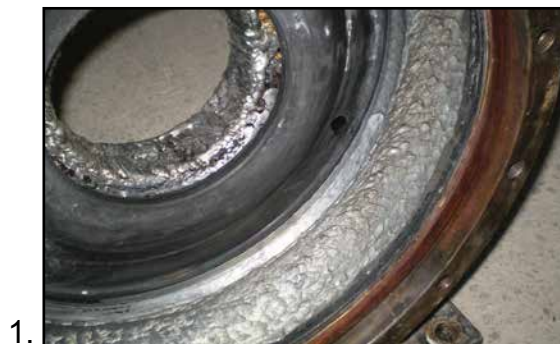
Pump erosion and corrosion every 6 months

Corrosion and erosion from chemicals (caustification plus CaCO_3 and CaO)

1. Damaged pump
2. After blasting
3. Belzona 1311 application
4. Belzona 1391 application
