SEALING A TRANSFORMER USING BELZONA

Transformer connections

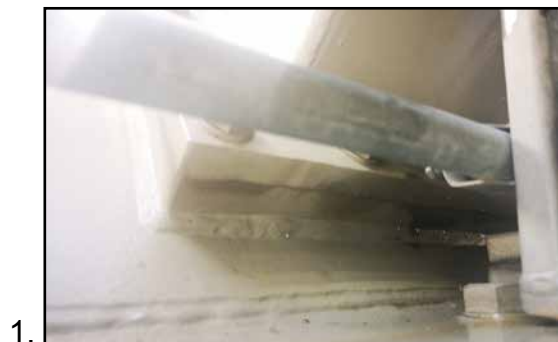
Various places from which oil has escaped due to a defective seal.

1. Assessment of the leak places
2. Machine grinding and cleaning the surface, and seal with Belzona 1212
3. Connection and screw heads with Belzona 1161
4. Screws and connection with Belzona 5831 seal
