## STRUCTURAL REINFORCEMENT OF PROCESS LINES WITH BELZONA SW II

Compliant non metallic structural reinforcement repair on process lines.

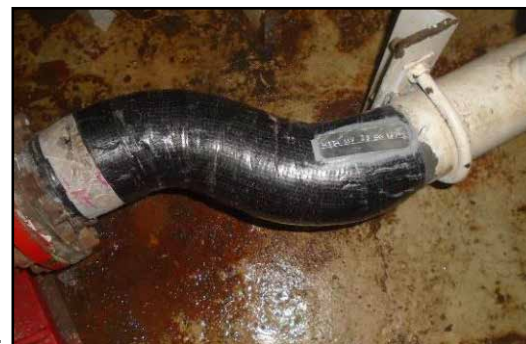
1. Application of Belzona SW II on elbow section
2. Application of Belzona SW II on T section
3. Application of Belzona SW II on straight section
4. Application of Belzona SW II on larger straight section

Surface preparation performed in accordance with NACE 2(=ISO 8501-1, Sa 2 1/2), through dry abrasive blasting to white metal with Sponge Jet system. Average surface roughness achieved of 89 microns. After surface preparation and cleaning, Belzona 9611 was used for emergency leak sealing in some areas, followed by Belzona 1111 to fill pits and smooth out application area. Belzona SW II system was then applied over the repair area for structural reinforcement of the equipment.
