BELZONA PROTECTS INNER TUBES OF TUBULAR CONVEYORS IN WOOD PLANT

Austria

September 2019

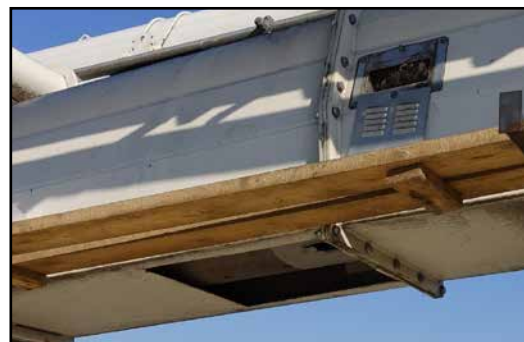
1. Box construction partially cut open so that the damaged areas were also accessible from the outside.
2. At the points with larger holes, a reinforcement plate was first glued on from the outside. Belzona 1212 applied on the blasted reinforcement plate.
3. Reinforcement plate positioned
4. Finished repair point in the lower tube
