## BELZONA EXTENDS THE LIFE OF SLURRY PUMP CASINGS

Copper Mining Company, Bulgaria

Three casings of Slurry pumps with removable thick rubber protectors at flotation production site.

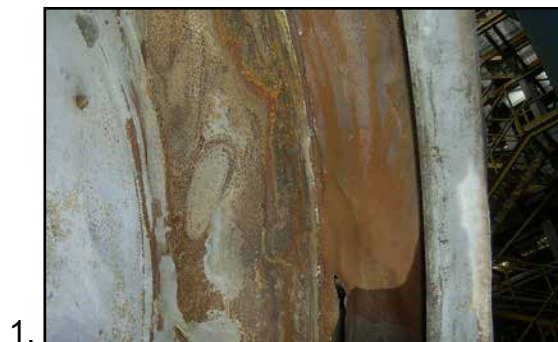
The casings were badly worn, even through the whole thickness in some places.

1. General view of casing before repair
2. Manual preparation of repaired surfaces
3. Application in progress
4. Final view of completed application.
