## WOOD PARTICLES DRUM REPAIRED WITH BELZONA

The customer needed to mix special glue with wood particles to achieve a uniform material for the production of boards.

The glue and wood particles mixture was very abrasive and the after a short period of time, there was localised damage to the drum.

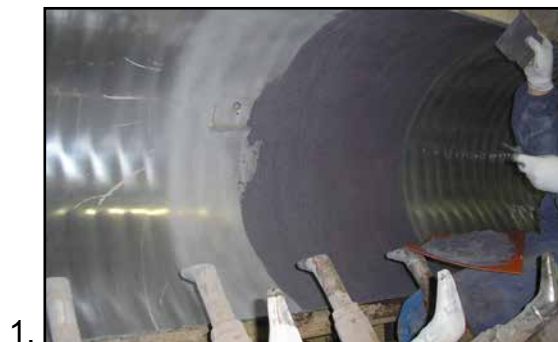
1. Surface after blasting - ready for repair
2. Belzona 1812 local application
3. Perfect protection against abrasive mixture
