CHIMNEY RESTORED WITH BELZONA

Oil refinery chimney, northern Poland

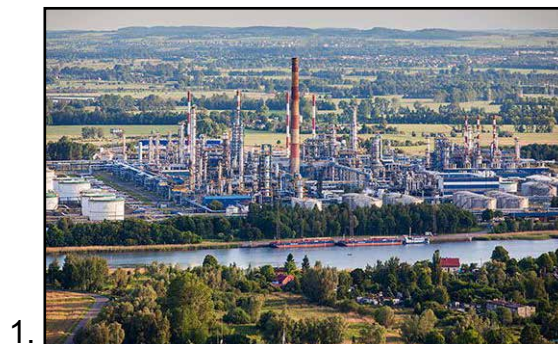
The 120-meter high chimney of the plant's combined heat and power plants required a new more durable coating protection. Previous coatings were very quickly tarnished and damaged.

1. The deteriorated chimney
2. The application underway
3. The completed job
4. The completed job

The application was carried out in Accordance with Belzona System Leaflet FBC-02 The chimney was cleaned, the old paint was removed by abrasive blasting to achieve a good surface profile. Then, Belzona 5911 Ceramic Cladding Conditioner was applied. Two layers of Belzona 5111 (Ceramic Cladding) coating were then applied onto a conditioned surface. The total area to be covered was 4,000 square meters.
