BELZONA SUPERWRAP II PATCH REPAIR TO HEAT EXCHANGER SHELL

Industrial Gas Supplier, Middlesbrough UK

August 2019

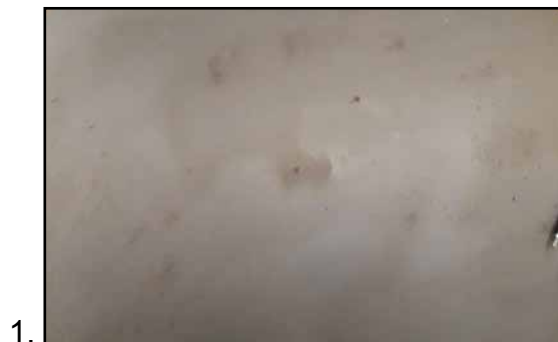
The heat exchanger had a through wall defect the size of a pin hole in its shell body. An NDT test had been carried out and it was showing wall thinning from within. The internals had been coated with a competitor material which is thought to have broken down, allowing internal corrosion.

1. Defect Area
2. Belzona SuperWrap II patch applied (Wet Lay-up)
3. Release Film applied
4. Completed application
