BELZONA 5871 PROTECTS LOCAL PAPER MILL NCG HEADER PIPING

Non-condensable gas header piping of dimensions 16 inch. OD and 100 ft. length and operating at 208 °F was suffering from corrosion under insulation.

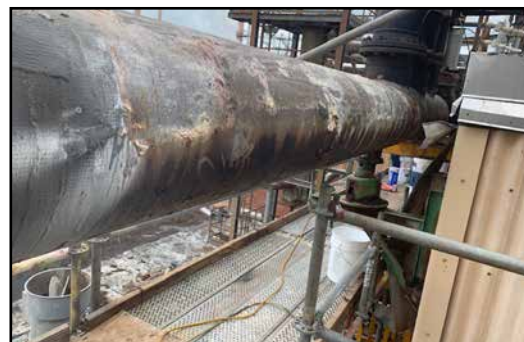
Some thin wall and through-wall defects (live leaks) were found on weld joints upon removal of the existing insulation.

1. Corroded pipe condition after insulation removal
2. Surface preparation
3. Temperature reduction on the pipe after 5871 application
4. Insulated piping
