INTERNAL OF A SCRUBBER REBUILT WITH BELZONA

Internal surface of a scrubber had become damaged in service

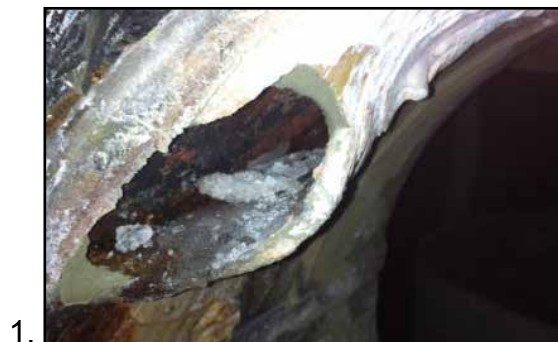
The internal surface and the ebonite coating of the scrubber were badly damaged by the rough conditions of the process (temperature up to 90degC and presence of chlorides and ammonia).

1. Before application
2. Junction between substrate and ebonite coating, chamfered with Belzona 1511
3. After application of Belzona 1391T
4. Final application
