BELZONA REFURBISHES OLD WEATHERED INDUSTRIAL ROOF

Miami, Florida. USA

April 2020

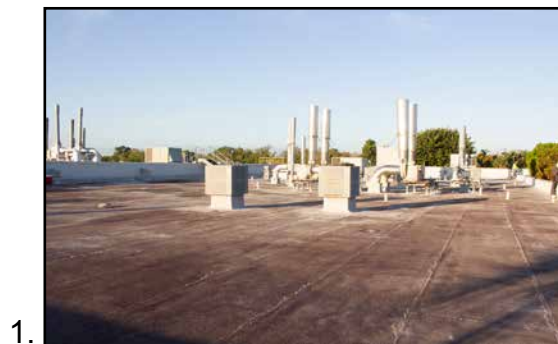
Numerous water leaks and deteriorated roof

1. Roof before product application
2. Surface preparation via pressure cleaning
3. Mesh being applied over joint
4. The finished area
