BELZONA REPAIRS PUMP CAISSONS

Pump caisson pipe suffering from external corrosion

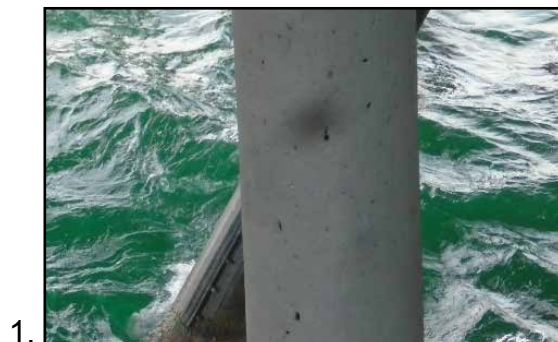
Through wall defects of pipe causing leakage of water with large areas of pitting.

1. Defective pipe
2. Doubler plate
3. Belzona 5831 1st coat
4. Belzona 5831 2nd coat
