BELZONA BONDS PLATES WITH MAGNET CONSTRUCTION SUPPORT.

Crude oil production plant in Slovakia.

Chemical corrosion leads to tank wall damage.

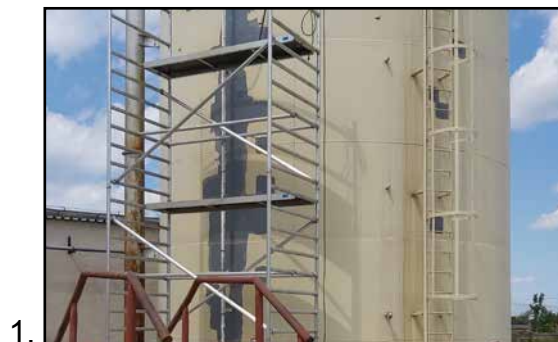
The tank was damaged by corrosion from aggressive residual water at crude oil production process. Because the customer needed very quickly repair he made decision to repair only damaged parts of the tank.

1. Tank was damaged by corrosion from aggressive residual water
2. Chemical corrosion leads to tank wall damage
3. Belzona 1111 was applied directly onto the prepared surface
4. Magnet construction keeps plate on the right place with sufficient pressure.
