## FAIRLEADS ASSEMBLY WITH BELZONA

Shipyards, TURKEY

Yacht with aluminum body

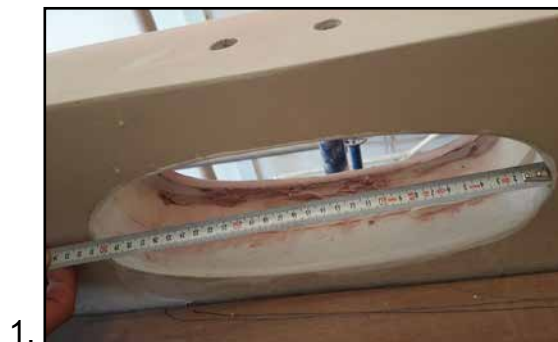
Conventional methods of installation fairleads result in voids between the fairlead and housing. Bi-metallic corrosion may occur between aluminum body and stainless steel equipment used.

1. Before application
2. After surface preparation
3. Application of Belzona
4. After Belzona application
