CARGO SHIP BOW THRUSTER REPAIRED WITH BELZONA

Vessel in shipyard required resurfacing of bow thruster tunnel before launch

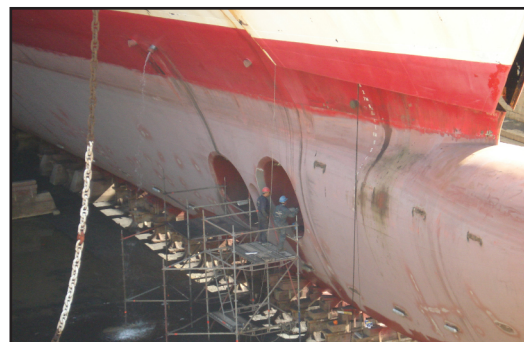
1. Vessel out of water
2. Significant pitting on upper surfaces
3. Completed Application

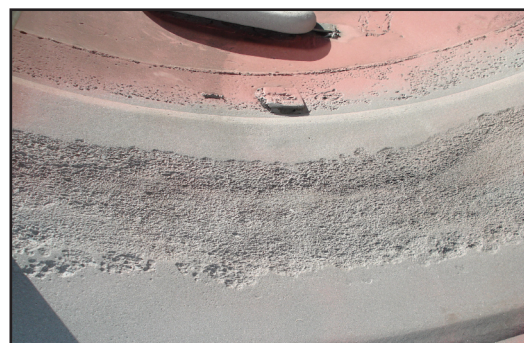
2.

Thruster tunnel suffers from erosion/corrosion that leads to cavitation and pitting

The repair was carried out in accordance with Belzona System Leaflet SOS 02. Damaged area was roughened to have a minimum profile depth of 3 mil and degreased with Belzona 9111. Belzona 1311 was applied to fill the pitting.
