## STEEL PLATE BONDING WITH BELZONA 1511 FOR BRIDGE

Rama IX Bridge, Bangkok, Thailand

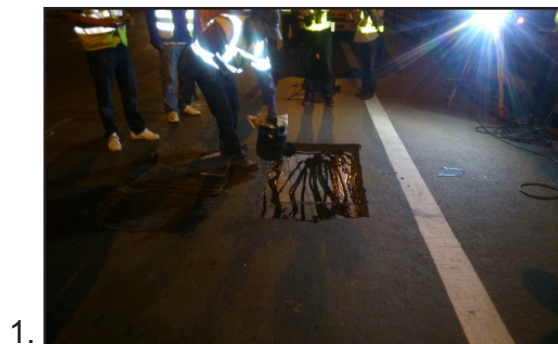
1. Belzona 1511 was applied on the repair area and on the prepared area of steel plate.
2. and 3 Place the steel plate on the repair area.

Drill a hole on the steel plate and tap in the screw to tighten the hook screw. The repair area was prepared with grit blasting and remove oil, grease, and contamination with MEK. And then, mix Belzona 1511 and apply it on the repair area and on the prepared area of steel plate, place plate on the repair area and leave cure. After that cut the hook screw and fill the asphalt to achieve the existing level.
