## BELZONA OVERHAULS A PUMP IN A WASTE INCINERATION PLANT

Duchting Pumpen MC 300-500 after many years of operation was damaged by numerous body cracks and other damage.

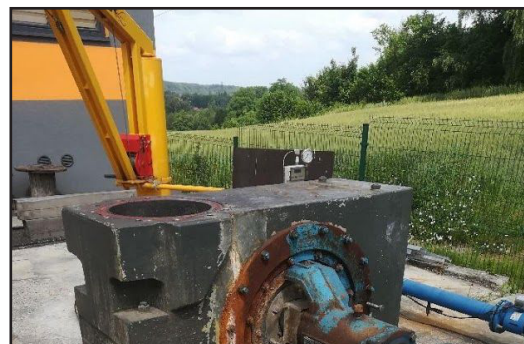
1. Damaged Pump
2. Cracked Casing to be repaired with Belzona 1111
3. Internal Lining coated Belzona 1381
4. Completed Application
