INDUSTRIAL FLOOR COATED WITH BELZONA

Maintaining the required hygiene and cleanliness of the production hall. Unevenness of the floor surface and damage to the pedestals arose as a result of intensive vehicular traffic of internal transport.

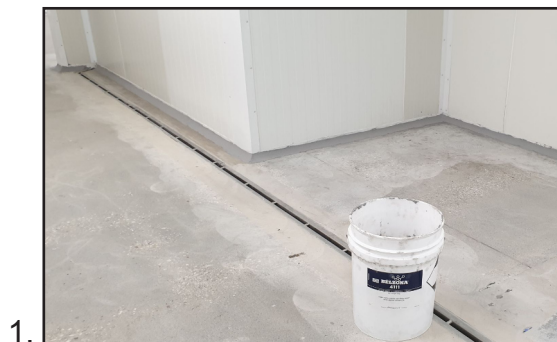
1. Damaged floor to be repaired with Belzona 4111
2. Vacuuming up any loose debris and dust.
3. Roller Brush Application of Belzona 5231
4. Completed Application
