BELZONA PROTECTS SEWAGE TREATMENT PLANT

Deterioration on the surface of the raw sludge thickener in the sewage treatment plant, meant that repair and protection was required

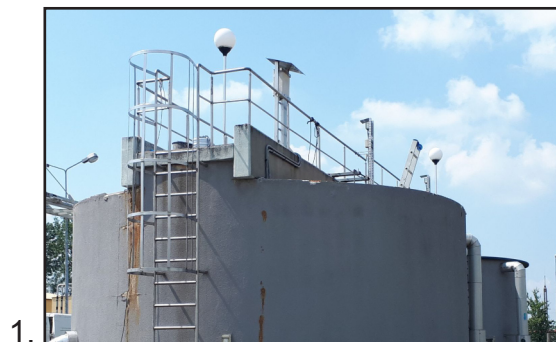
1. Treatment tank
2. Area to be repaired
3. Area rebuilt
4. Area protected with Belzona 5811

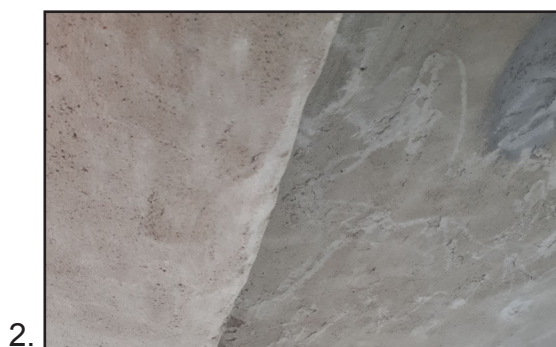
Strong and progressive corrosion of the concrete in the area of the sewage mirror and in the ceiling part of the sludge thickener.
