## BELZONA PROTECTS PUMPS FOR WATER TREATMENT PLANT

**APPLICATION SITUATION**  
Water treatment pumps required protection

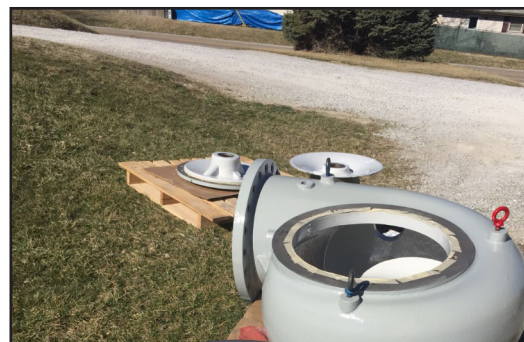
**PICTURES**  
1. -3. Completed application

**APPLICATION METHOD**  
Belzona 1331 was applied to the grit-blasted internals of the pumps
