BELZONA PROTECTS A LOADER

battery acid spillages onto the loader had caused the previous coating to fail, leaving the metal below open to chemical attack.

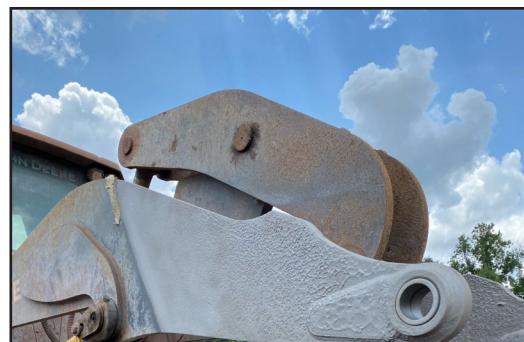
1. Grit blasted area
2. Grit blasted area
3. Coating applied
4. Coating applied

The areas that required protection were grit blasted back to white metal. Belzona 4311 was then mixed and applied.
