PUMP COATING WITH BELZONA 1341

APPLICATION DATE
09/09/2019

APPLICATION SITUATION
High pressure pump with 7 stages (KSB Multitec A100 / 7-8) The new pumps, which came directly from the manufacturer, are required to operate snow-making systems in a ski area.

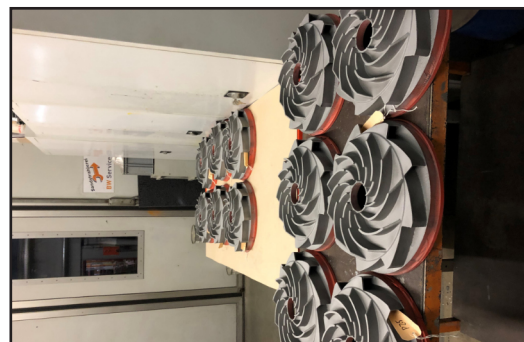
1. Sandblasted guide vanes
2. Coated impeller which is machined with CBN inserts
3. Finished guide vane in the housing
4. Pump during assembly

APPLICATION METHOD
The pumps were delivered directly to our service center by the manufacturer. We then dismantled the pumps and measured the clearance on the impellers. The running wheels were then turned on the lathe in order to obtain the original dimensions at the end. All components of the pump were sandblasted SA.2.5 After sandblasting, the components were immediately coated with Belzona 1341 Supermetalgilde. After a curing time of 14 hours, the wheels were turned back to their original dimensions on the lathe with the help of CBN inserts. Before assembly, the impellers were checked for imbalance and balanced.
