## BELZONA RE-SEATS BEARING ON RUDDER SHAFT

Damaged rudder shaft

Rudder shaft was worn under the bearing requiring repairs to the shaft for full bearing contact.

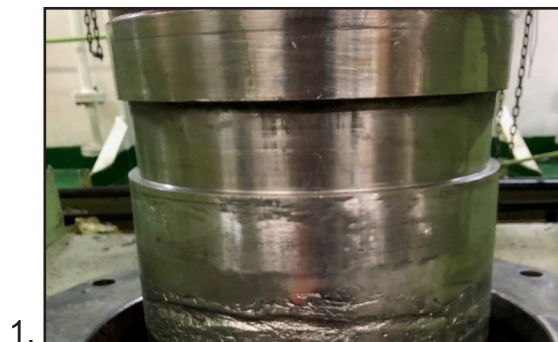
1. Damaged shaft after preparation.
2. Belzona 1121 applied onto the shaft and bearing.
3. Bearing lowered into position for curing.
4. Bearing removed and Belzona 1121 inspected.

The new bearing was used as a former using the slip method following a modified version of Belzona Know How repair leaflet SOS-9. Two coats of Belzona 9411 release agent were applied on the inside of the new shaft bearing and allowed to fully dry. Shaft was prepared using power tools to remove all corrosion deposits and loose substrate. Belzona 1121 Super XL-Metal was mixed and applied by brush onto the shaft and the inside of the bearing. Additional Belzona 1121 was troweled onto the shaft and bearing. Bearing was lowered onto the shaft, excess Belzona 1121 was removed, and the repair was allowed to cure for 24 hours. The bearing was removed to inspect that there was at least 80% contact between the shaft and bearing.
