## BELZONA REPAIRS, PROTECTS & IMPROVES PUMP TURBINES IN THE PETROCHEMICAL INDUSTRY

Water pump on a petrochemical site.

Water pump impellers were suffering extensively from cavitation and erosion.

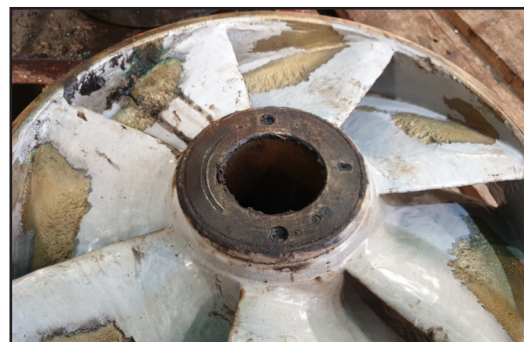
1. Damage sustained on the impeller
2. Impeller once taken back to the substrate
3. Impeller after rebuilding
4. Finished product
