BELZONA FLEXIBLE MEMBRANE SEALS LEAKING CONCRETE GARAGE ROOF

Leaking concrete garage roof

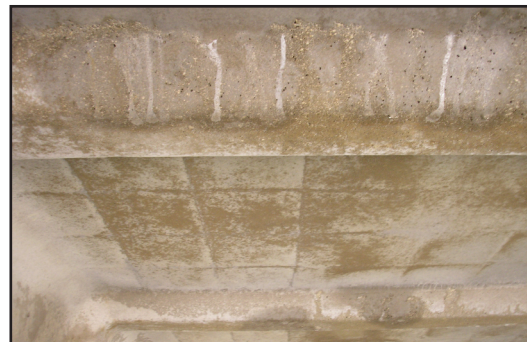
Water, leaking through the concrete roof, was falling on the warehouse goods and damaging it.

1. Leaking concrete garage roof
2. Application of Belzona 3911 to concrete surfaces
3. Application of Belzona 3111
4. Ready to use
