BELZONA 1212 FOR EMERGENCY PUMP REPAIR

APPLICATION SITUATION
Wastewater lift station pump

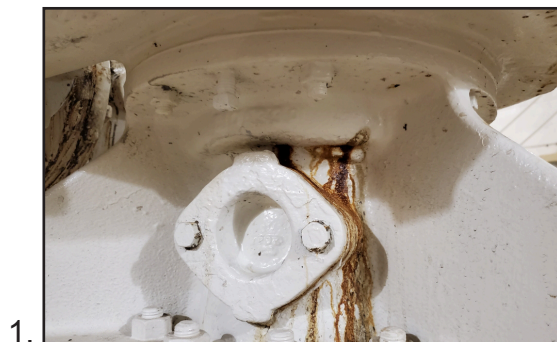
PROBLEM
A faulty section of weld on the lower side of the pump was leaking raw sewage.

1. Original condition of the pump.
2. Paint removed and ready for the 1212.
3. First application of 1212 with a small drop of water on the left side.
4. Second application of 1212 and leak sealed.
