## BELZONA USED FOR THE PROTECTION OF A WIND TURBINE BLADE

Erosion of the leading edge of the blades caused by impact from rain droplets. Routine inspection and periodic repair is required to keep the turbine running efficiently.

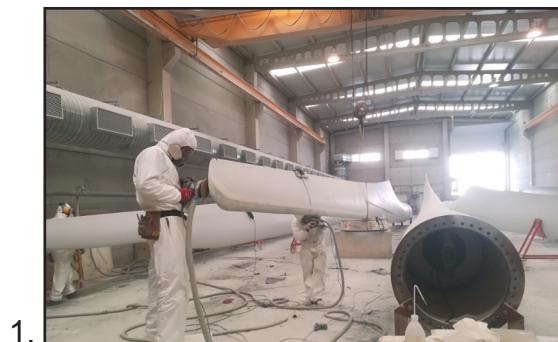
1. Surface preparation
2. Application of Belzona 5721
3. First layer complete
4. Final layer complete

The leading edge of the blade has been prepared using hand held sander power tool, removing the existing gel-coat and to provide a clean and rough surface. After cleaning the prepared area, the Belzona 5721 system has been applied as a one-coat system at an average of 500 microns.
